This report comments on the seismic performance of a Reinforced Concrete Frame building with masonry infill walls situated near the IIT Kanpur main campus entrance gate.

Building description: It's a two storey RC building with masonry infill used for commercial purposes. It's situated near a railway line.

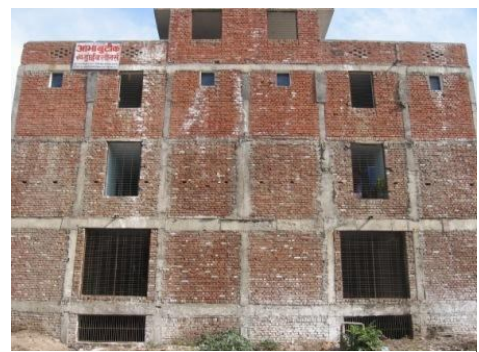
Masonry was provided as infill which may not be very good for seismic performance of the building. For the good earthquake performance masonry infill walls are supposed to be isolated from the frame which was not the case here.

Short columns can be seen in the building. Short columns perform very badly during earthquakes due to induced high shear forces in them. Captive columns (partially restrained by the wall) can also be seen which is expected to perform very badly during earthquakes.

Figure 1(i) RC frame building with masonry infill  
(ii) short columns in the first floor

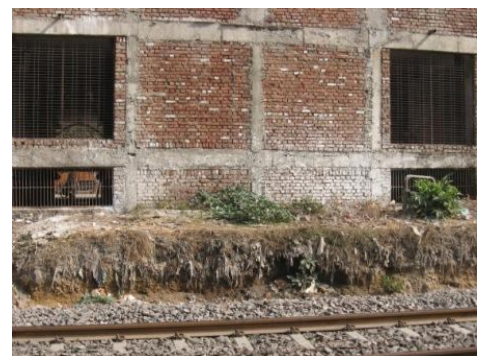
As can be seen from the building it follows the "weak column-strong beam". During earthquakes forces are transferred from beams to columns, so column should be

Figure 2 weak column and strong beam design

designed to be stronger in bending than the beams, in this way beam will fail first rather than columns, so the complete collapse can be avoided.

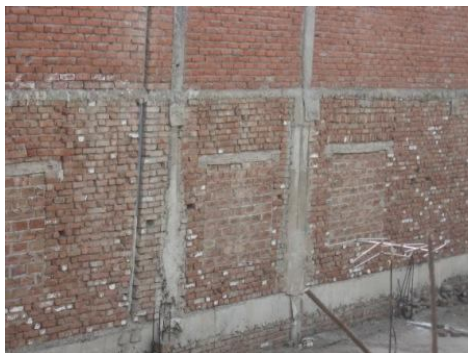
Figure 3. Pipe installation through beams and walls

Poor construction practices were followed. Exposed reinforcements, pipe installation through the load walls and beams could be seen in the structure.

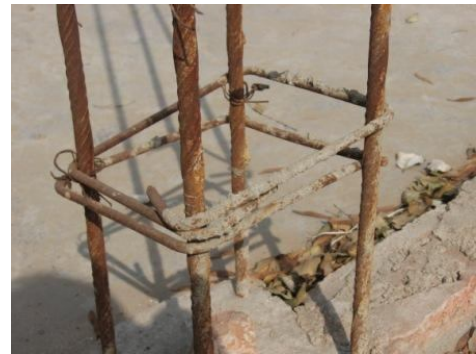
It could not be deduced just looking the structure whether “ductile detailing” of the structure has been followed or not. However some general observations shows that 135° hooks has not been provided and they have a bent angle of 90° also some exposed portion of the reinforcement showed that stirrups are not according to the norms provided in IS code. So overall it can be inferred that ductile designed has not been followed. Extended bars can be seen at the top of building columns. Extended bar for future construction become excessively corroded and thus should be avoided.

Figure 3. 90 degree hooks

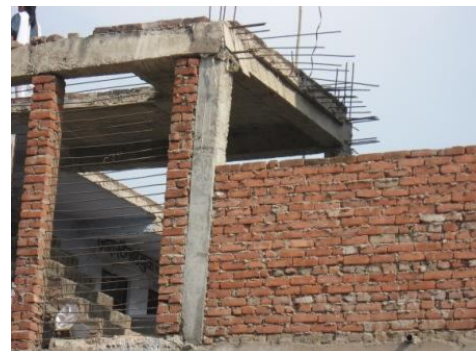
Beam columns joints were very poor at many places not properly connected and with poor reinforcement detailing. At some places mixed connections were used like reinforced concrete beams resting on masonry columns which can be detrimental to the structure under earthquake loads.

Figure 4 Poor beam column connections

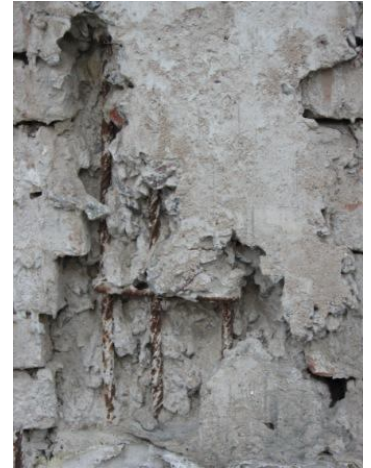
Figure 4 Exposed reinforcement
