This report comments on the seismic performance of a Reinforced Concrete Frame building with masonry infill walls situated near the IIT Kanpur main campus entrance gate.

Building description: It's a two storey RC building with masonry infill used for commercial purposes. It's situated near a railway line.

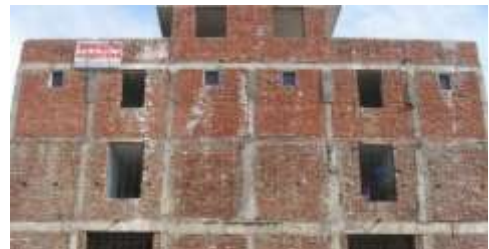
Masonry was provided as infill which may not be very good for seismic performance of the building. For the good earthquake performance masonry infill walls are supposed to be isolated from the frame which was not the case here.

Short columns can be seen in the building. Short columns perform very badly during earthquakes due to induced high shear forces in them. Captive columns (partially restrained by the wall) can also be seen which is expected to perform very badly during earthquakes.

Figure 1(i) RC frame building with masonry infill  
(ii) short columns in the first floor

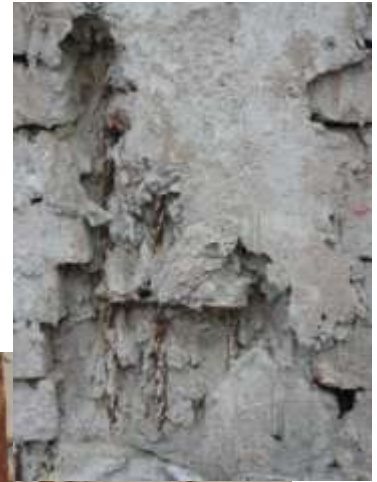
It could not be deduced just looking the structure whether “ductile detailing” of the structure has been followed or not. However some general observations shows that  $135^\circ$  hooks has not been provided and they have a bent angle of  $90^\circ$  also some exposed portion of the reinforcement showed that stirrups are not according to the norms provided in IS code. So overall it can be inferred that ductile designed has not been followed. Extended bars can be seen at the top of building columns. Extended bar for future construction become excessively corroded and thus should be avoided.

Figure 3. 90 degree hooks

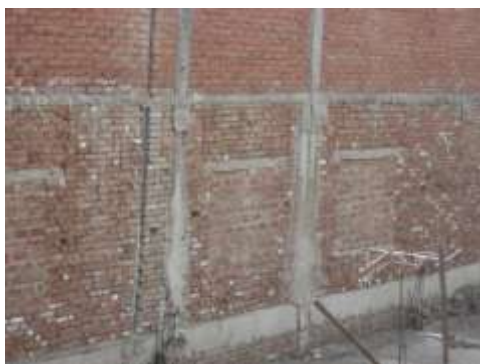
Poor construction practices were followed. Exposed reinforcements, pipe installation through the load walls and beams could be seen in the structure.

Figure 3. Pipe installation through beams and walls

Figure 4 Exposed reinforcement
